NATIONAL PROGRAM FOR INSPECTION OF NON-FEDERAL DAMS  
PIERCE POWER DAM (NH..IU) CORPS OF ENGINEERS WALTHAM MA  
NEW ENGLAND DIV FEB 79

PERCE POWER DAM  
NH 00230

PHASE I INSPECTION REPORT  
NATIONAL DAM INSPECTION PROGRAM

11. CONTROLLING OFFICE NAME AND ADDRESS DEPT. OF THE ARMY, CORPS OF ENGINEERS NEW ENGLAND DIVISION, NEDED 424 TRAPELO ROAD, WALTHAM, MA. 02254		12. REPORT DATE February 1979

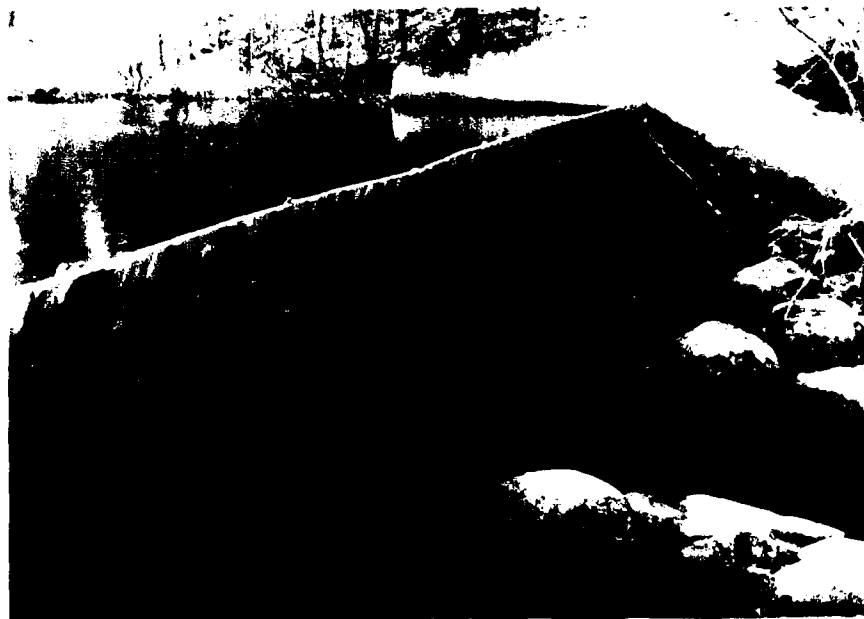
Figure 4 - Looking at the crest of the dam from the  
 river. About 100 feet wide and 10 feet deep.

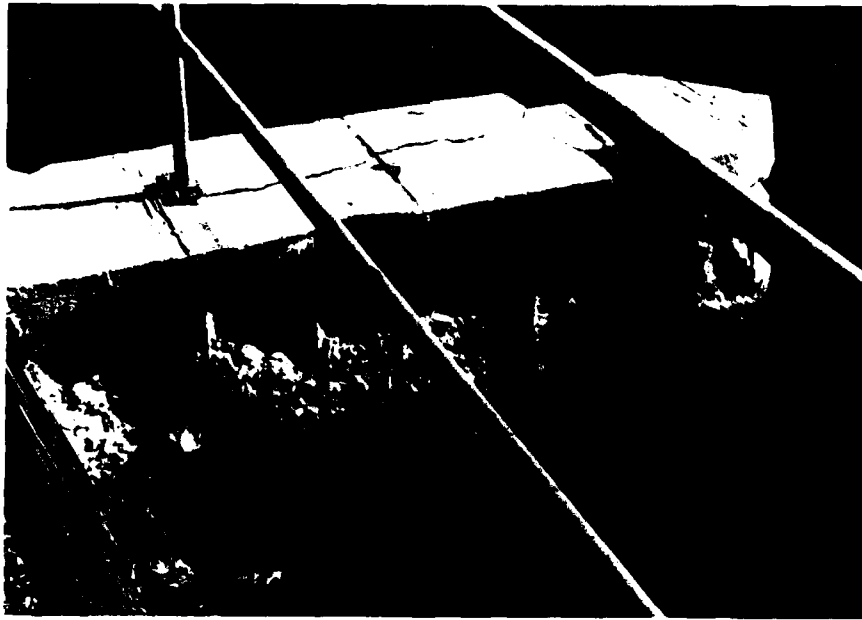
c. Appurtenant Structures. Visual inspection of the gate structure on the upstream face of the powerhouse was limited to the visible portion above the water line. The leading edges of the gate intake structure have deteriorated and reinforcing steel is exposed above the water line. (See Appendix C - Figure 8.) Portions of the gate support walls have eroded up to 3 inches. Limited areas of the concrete walkway in front of the trash racks have also eroded, exposing some of the reinforcing steel in the deck. The submerged condition of the gates prevented inspection; however, the gate operating mechanisms were noted to be in good condition. (See Appendix C - Figure 9.)

Figure 8 - Looking at the deteriorated leading edges of the gate intake structure. Note the exposed reinforcing steel.

- (1) Evaluate the seepages next to the powerhouse and to design remedial measures.
- (2) Design and specify remedial repairs for the deteriorated concrete in the dam and appurtenant structures.
